Straub Hall  
University of Oregon

**Report #1**  
**Envelope Renovation Study**

September 2012

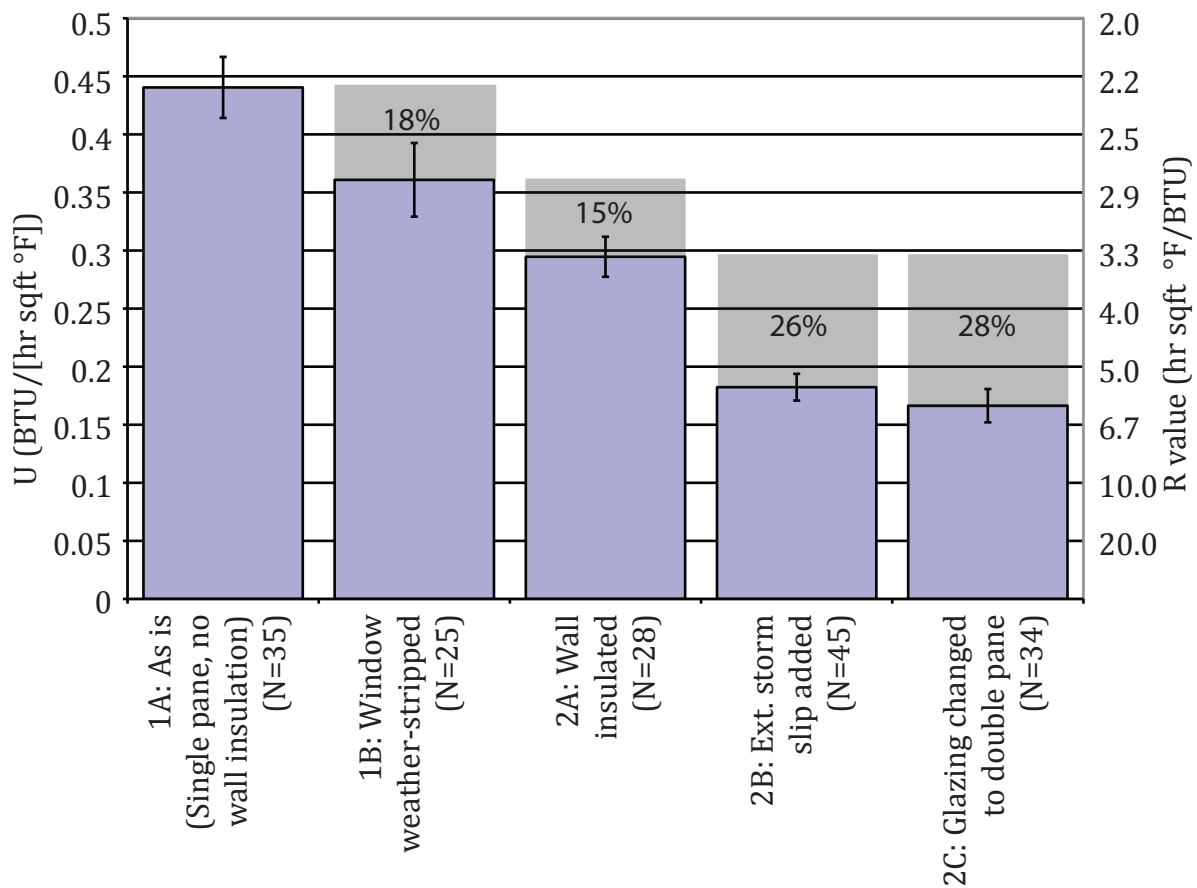
Figure 3, Straub Coheating Summary

The following chart (Figure 3) shows the change in performance for each of the window and wall improvements tested. It is specific to the window and wall area tested and does not represent the whole building. As seen in the chart, the overall U-value of the test window/wall assembly reduced 61%, from 0.44 to 0.17 BTU/hr-sf-°F, from the base case to the final configuration. The U-value reduction from baseline for each improvement is as follows: 18% for weather stripping, 15% for insulation, 26% for slips, and 28% for double pane. In other words, if only insulation would be added, the window/wall assembly would have a 15% reduction in U-value. Note that the double pane and the storm slip are alternates and only one of the two would be included; therefore, both are compared to Test 2A.

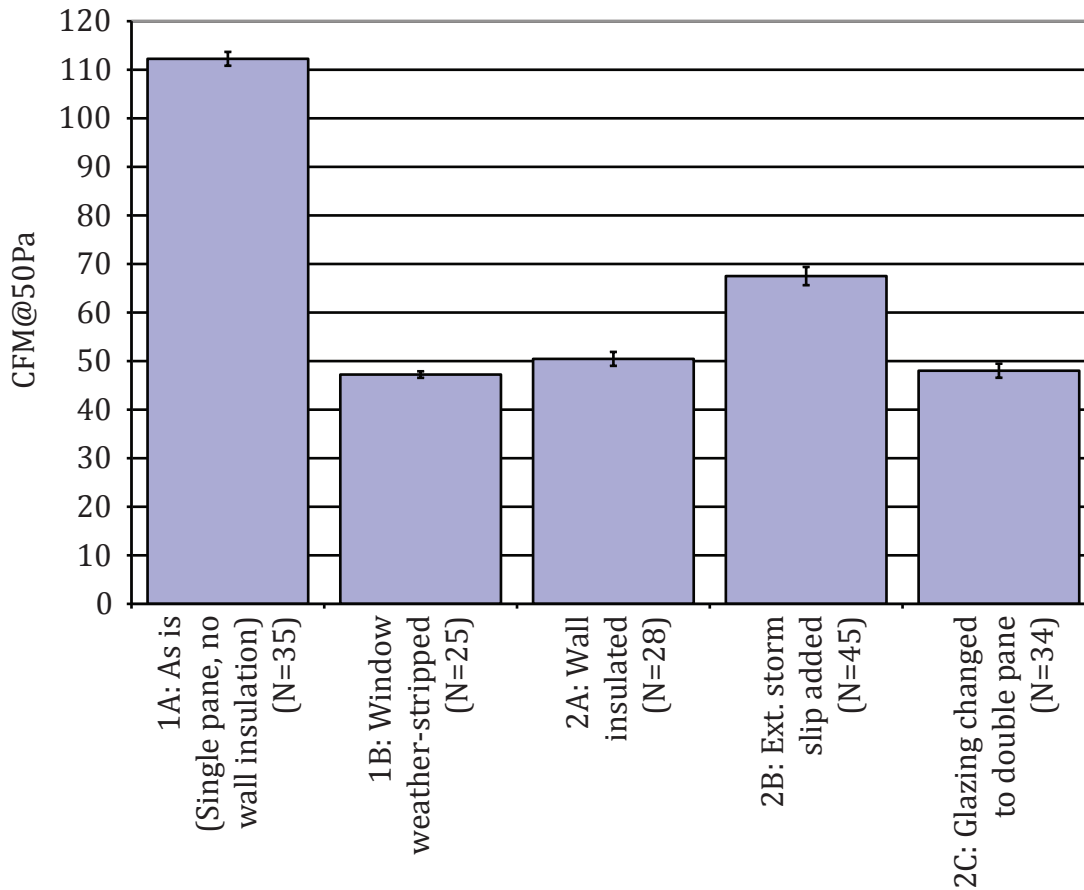
**Figure 5, Straub Blower Door Summary**

The following chart (Figure 5) shows the results of the blowerdoor tests. These values are airflow rates at 50 Pa and do not represent rates at usual wind pressures. Note that in Test 2B leakage increased for an unknown reason. Using sashes from another window may potentially have been the cause for this increase; note that the sash used for the slip test were taken from a neighboring window and may not have had a good fit in the test window. It is recommended that retrofitted sash units be replaced into their original frames.

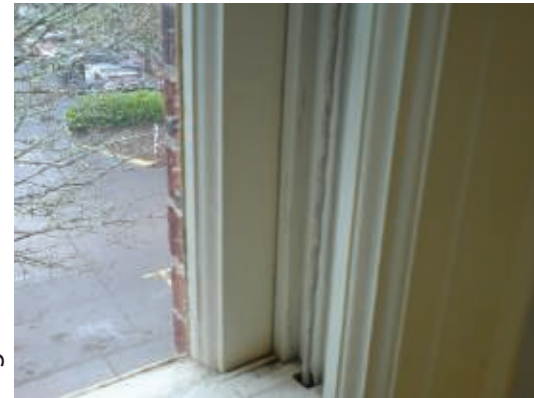
TEST 1A

Existing window before treatment

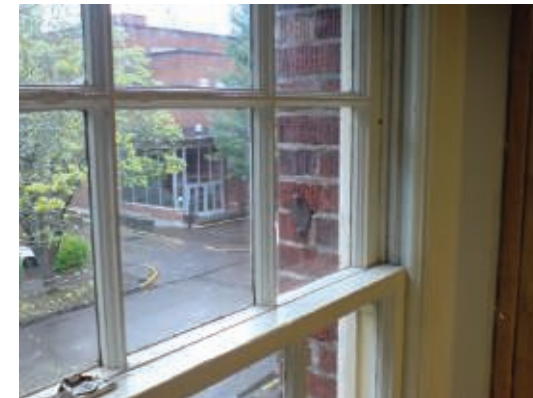
TEST 1B

Window has been weather-stripped

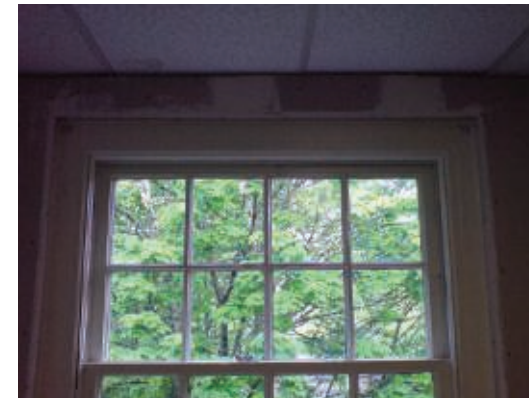
TEST 2A

Wall insulation added

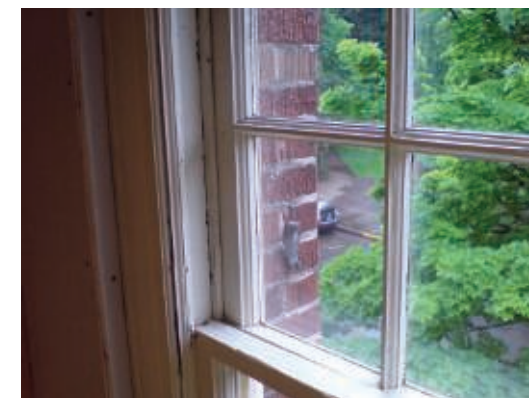
TEST 2B

Sash & glazing replaced for units with slip installed

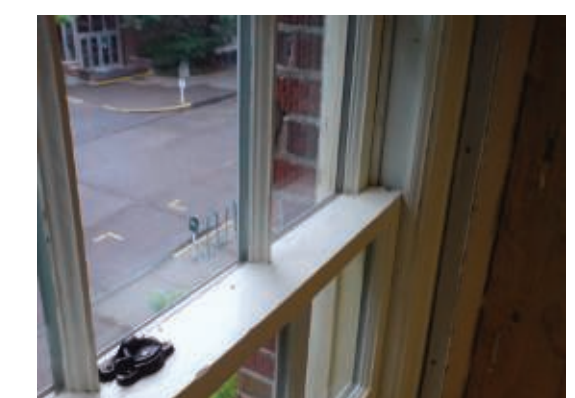
TEST 2C

Original sash reinstalled with double glazing replacing original single glazing

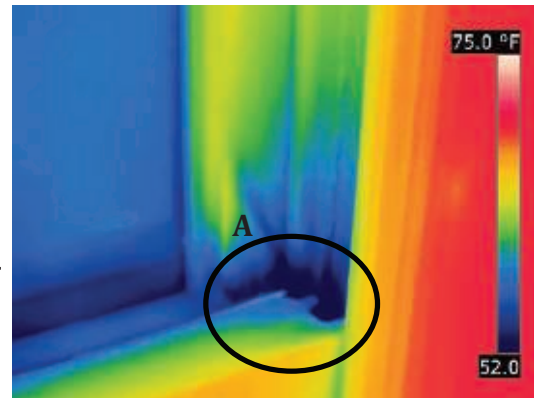
A: Noticeable infiltration in between check rails especially near the jamb

The windows should be weather-stripped. If the existing sashes are to be used, it is recommended that retrofitted sashes be reinstalled into their original frames. Additionally, the counterweight cavity should be sealed as well as filled with insulation.

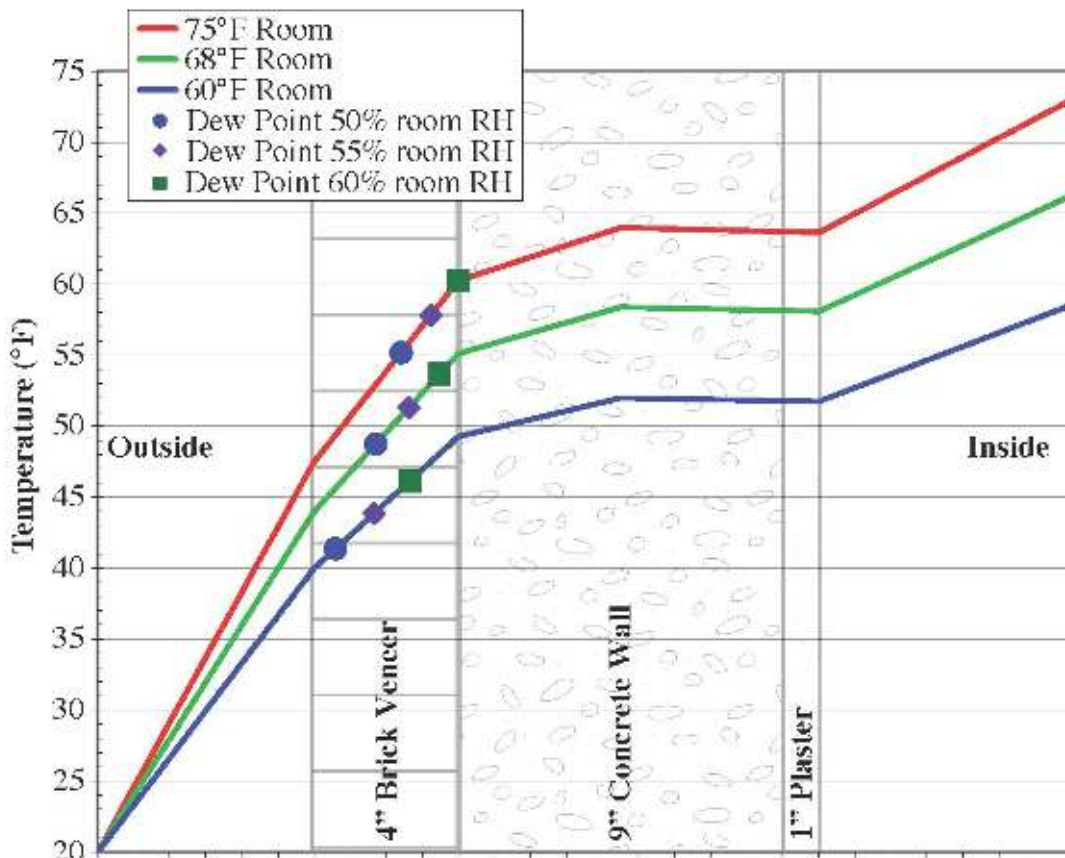
Figure 7, Non-insulated Wall Dew Point and Temperature Profiles

In the non-insulated wall, under operating conditions the dew point will likely occur between the outer surface of the concrete and the outer surface of the brick.

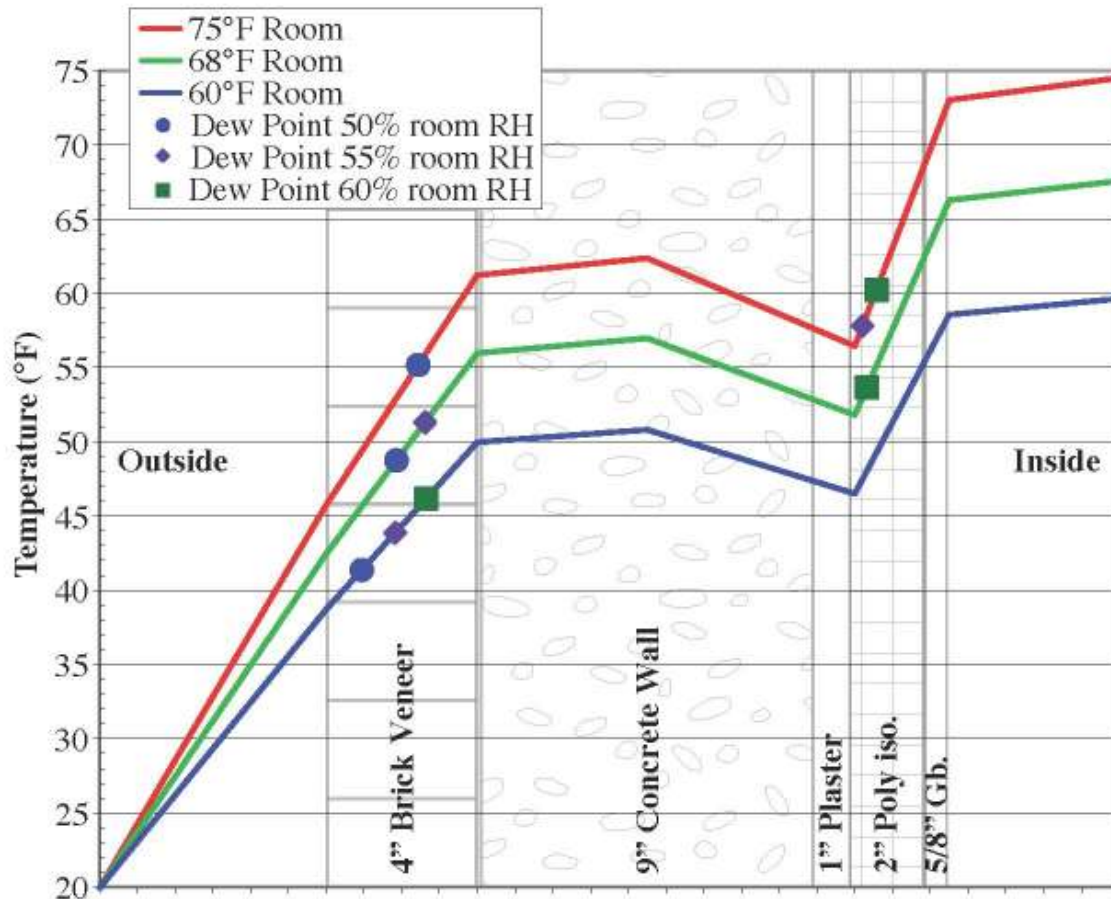
Figure 8, Insulated Wall Dew Point and Temperature Profiles

In the insulated wall the dew point occurs in the brick veneer with lower temperature/humidity conditions and between the finished wall and plaster in higher temperature/humidity conditions. With the dew point occurring inside the inner surface of the concrete under operational conditions, a vapor barrier should be added to avoid moisture build-up. The vapor barrier should be located between the interior atmosphere and the rigid insulation.

Insulation should be added to the exterior walls. Also, based on the wall monitoring results, a vapor barrier should be provided either on the inside finished surface of the wall or between the insulation and gyp board.

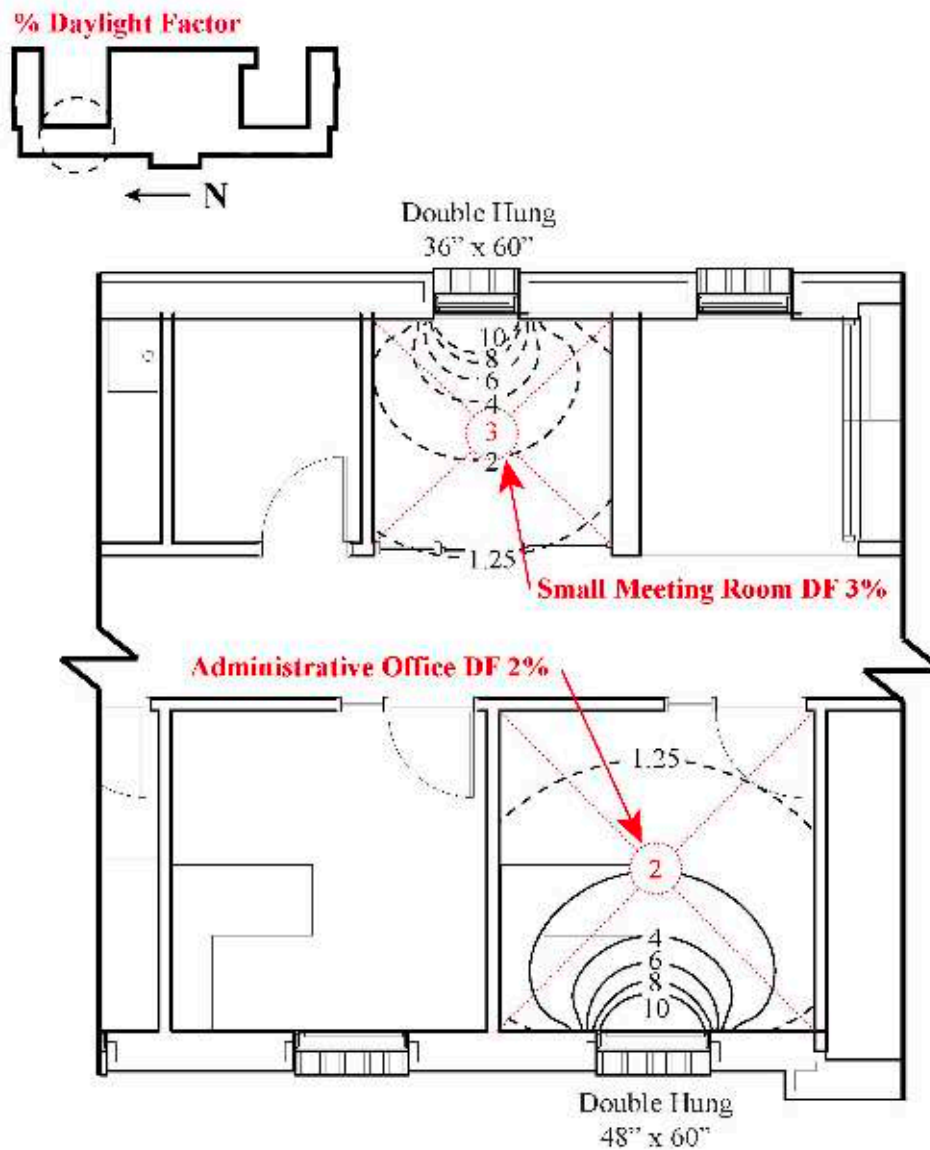
Figure 9, Daylighting Contours of Typical Spaces

Daylight Factors were estimated to be between 2-3% in the middle of the space for a typical room (see Figure 9). For a December noon overcast day this will produce an interior illumination of 13-20 foot-candles, and at noon in April an interior illumination of 42-63 foot-candles. Also, with the high gradient between the window and the back wall, glare could be an issue. Glare control should be considered for the perimeter spaces. Corridors were not included in the analysis but isolux patterns indicate that relighting the hallway from the offices is feasible. More in-depth calculations would be needed to verify corridor daylighting potential.
