Straub Hall  
University of Oregon

**Report #1**  
**Envelope Renovation Study**

September 2012

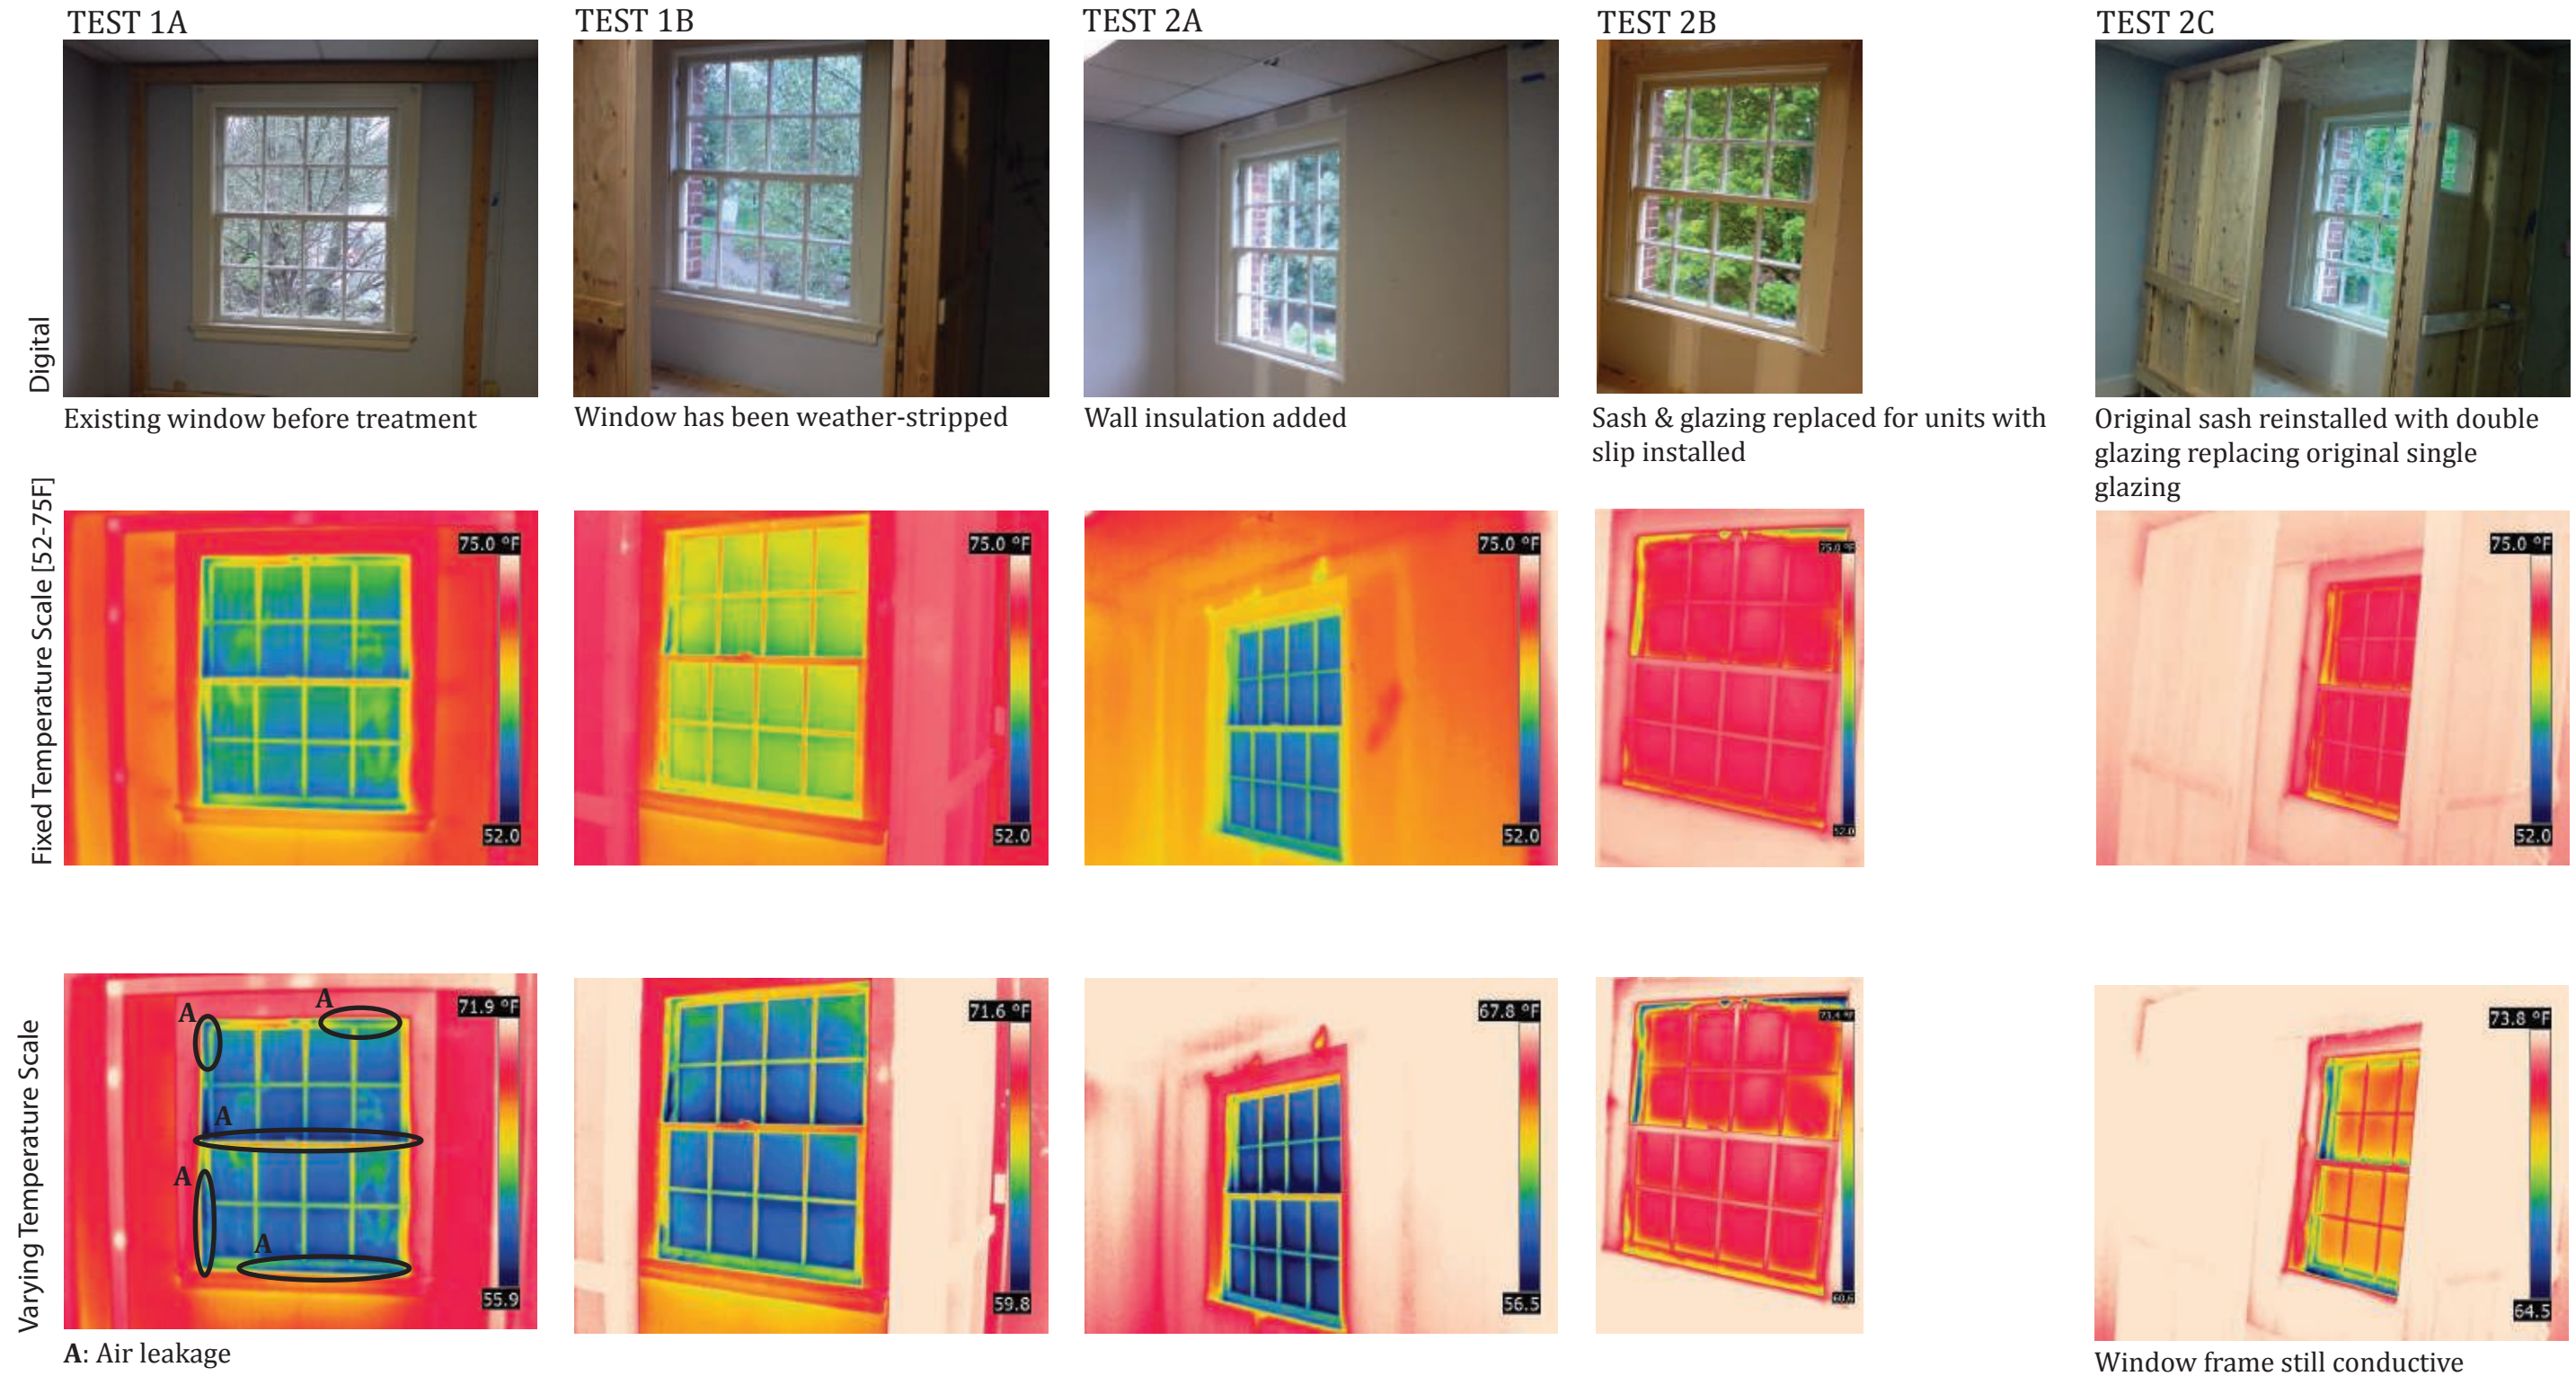
# Straub Hall Infiltration Tests: Whole Window and Wall

Infrared imaging was used to establish the infiltration locations around the window as well as thermal bridges in the wall assembly. The following IR images were taken during each of the tests to visualize the changes. The testing starts with the existing window and wall assemblies (1A) followed by the improvements: add weather-stripping, add wall insulation, add slips to glazing, and replace slips with double glazing.

These images were taken while depressurizing the room. Therefore, sources of infiltration can be seen where incoming cold air cools surfaces.

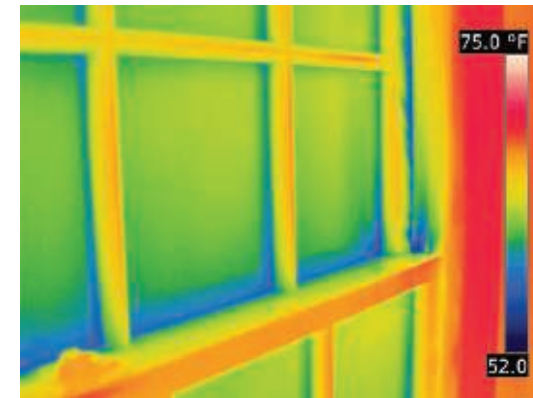
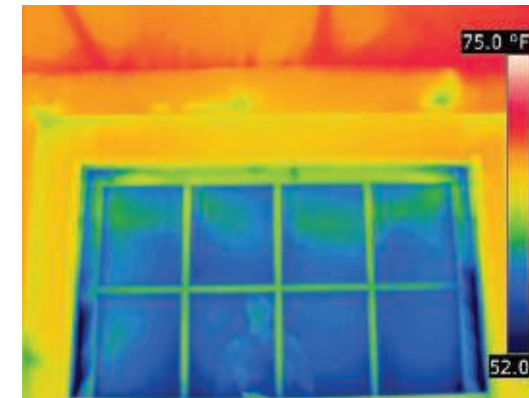
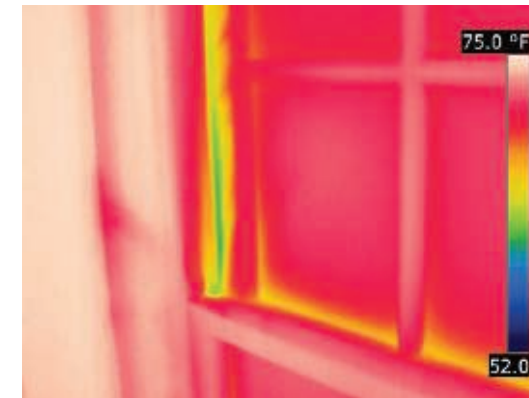
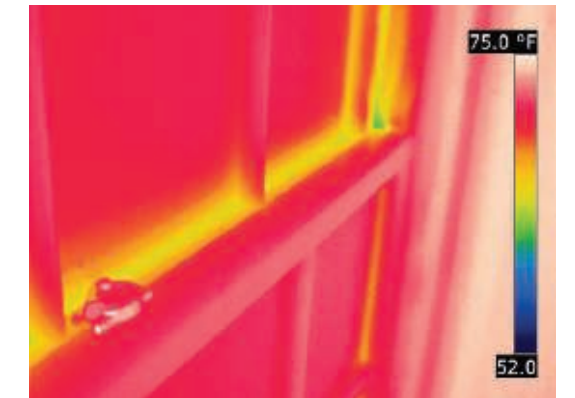
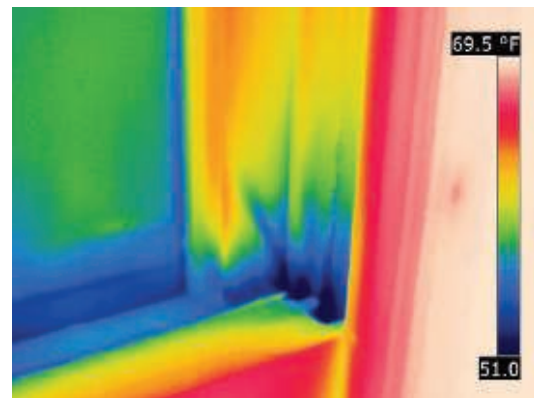
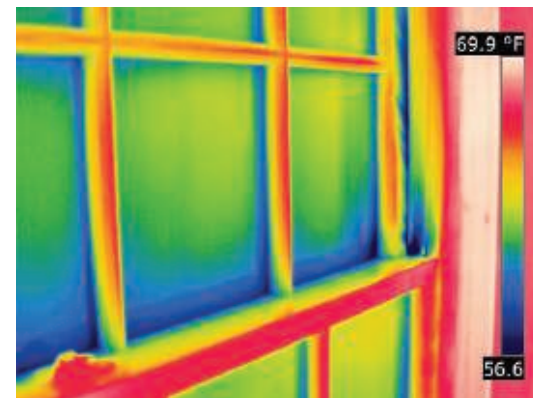
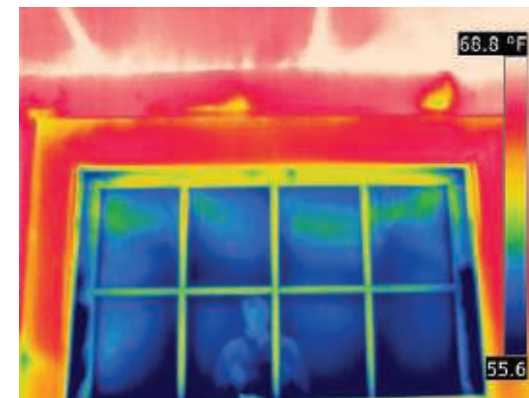
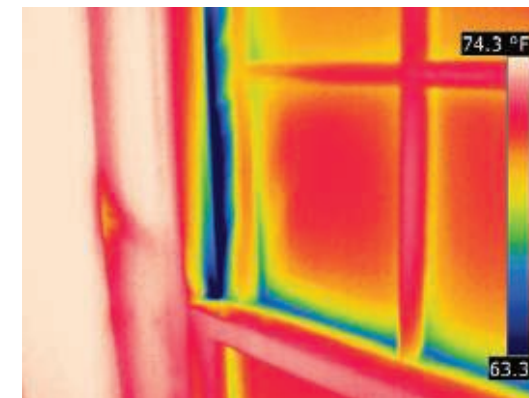
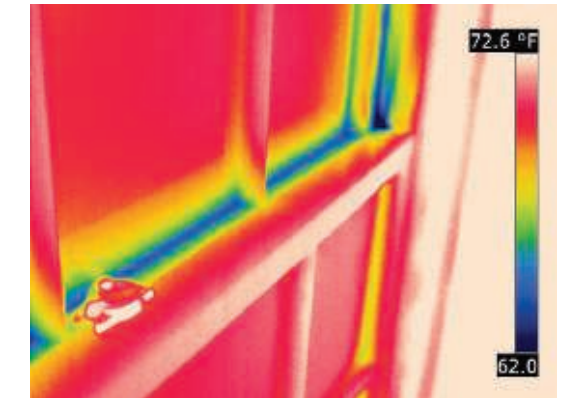
**Straub Hall Infiltration Tests: Check Rail**

A: Noticeable infiltration in between check rails especially near the jamb

The windows should be weather-stripped. If the existing sashes are to be used, it is recommended that retrofitted sashes be reinstalled into their original frames. Additionally, the counterweight cavity should be sealed as well as filled with insulation.
