REPORT #E20-399

Commercial Window Attachments: Secondary Window Market Characterization

University of Oregon Straub Hall

Secondary Window Attachment Case Study

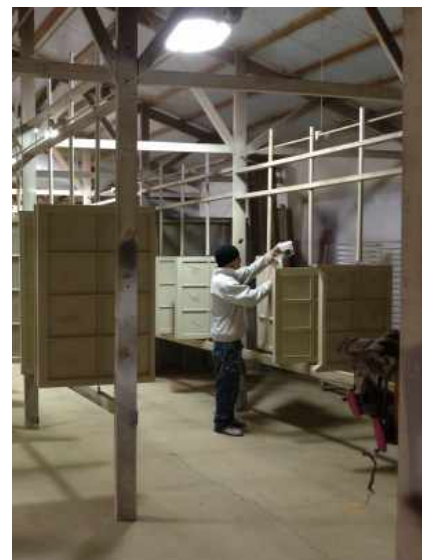
Chosen Windows restoring Straub Hall window sashes in shop

- 1. Before Installation:** Chosen Windows removed the existing window sashes and took them back to their Portland shop. Because the windows renovation was part of a larger renovation, it was easier for Chosen to take the window sashes back to their shop rather than work around the other subcontractors on the renovation. At the shop, the original window sashes were stripped down, and the SLIP attachments were installed.

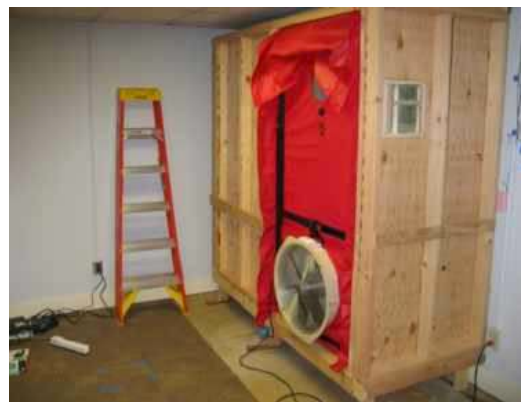
UO Energy Lab testing windows in Straub Hall

The University of Oregon hired the on-campus Energy Studies in Buildings laboratory to test the effectiveness of the following scenarios: the original windows, windows with one layer of insulated film, insulated glass conversions, and Chosen Windows's SLIP attachments. Analyses from the UO energy lab confirmed the following:

1. Even one layer of insulated film provided significantly better insulation than the original windows.
2. The insulated glass conversion option and the SLIP attachments provided nearly identical levels of insulation.

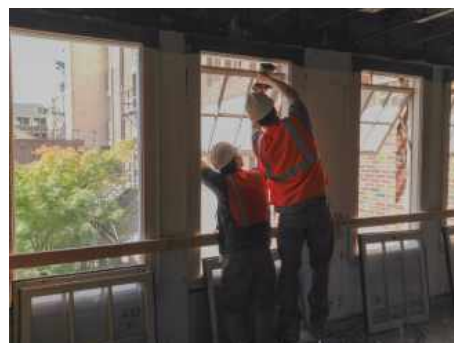
An example of a window re-installation

- 3. Installation:** After re-balancing the weight system and coordinating with other subcontractors on the project (e.g., the insulation subcontractor), Chosen Windows installed the new windows. Each window took approximately 2 to 4 hours to install (also accounting for the time it took to rebalance the weights), and the installation generally went very smoothly. However, Chosen Windows stated that a few window attachments had to be removed and reinstalled, as other subcontractors would occasionally accidentally scratch the windows.

The architects on the project performed quality assurance checks, which included a visual inspection of the windows and a spray test, which involves spraying the glass with a controlled stream of water to make sure that there were no leaks on the inside. The re-installed windows passed both tests.

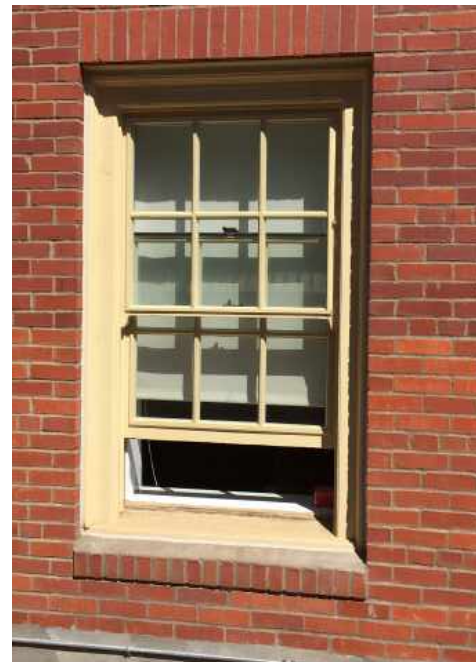
Window with SLIP attachment added
